ADVANCED MASTERS IN STRUCTURAL ANALYSIS
OF MONUMENTS AND HISTORICAL CONSTRUCTIONS

Master's Thesis

Stability Analysis of
Famagusta Churches: St.
George of the Latins

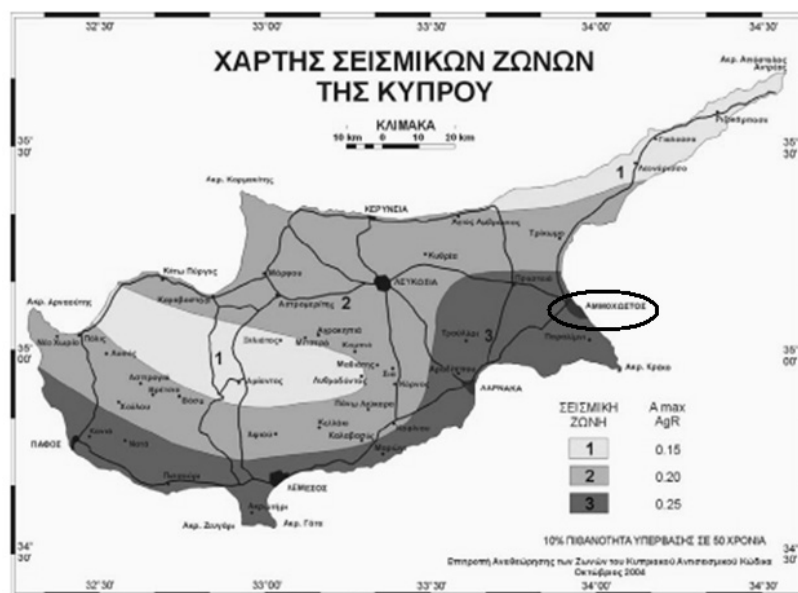
Figure 2.6. Definition of reference peak ground acceleration (PGA) on rock among Cyprus territory (CYS EN 1998-1:2005, 2007)

Notwithstanding that Cyprus lies in high activity seismic zone, the area where most number of historical records and instrumental data has been recorded is the coastal zone that extends from Pafos through Limassol and Larnaca and then to Famagusta. Large number of medium to strong earthquakes have epicenters in the sea, which may cause small to negligible damage, but many other earthquakes have epicenter in the west and south regions of the island, affecting more these areas of the country rather than the others (Unit of Environmental Studies, 2004). According to the Seismic Hazard Map of Cyprus (shown in Figure 2.6), the maximum peak ground acceleration (PGA) on rock for the south and west regions, where Famagusta is included, is about 0.25g. This value is the highest within the whole territory compared with the minimum PGA of 0.15g, which is shown in the north and center regions.

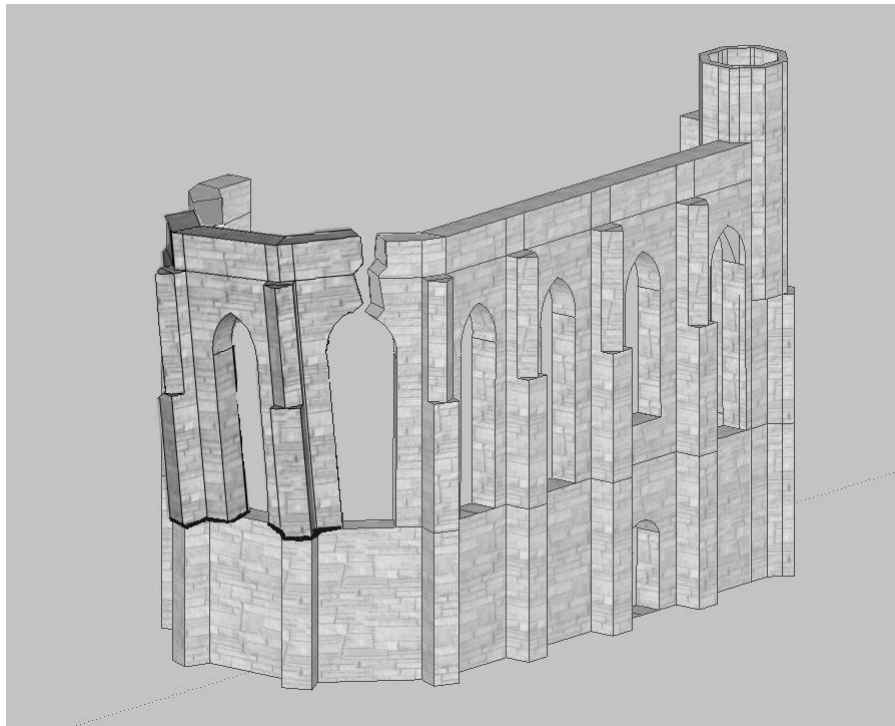
The macro-element defined for this collapse mechanism includes pier walls number 6 and number 7 (see Figure 3.13). It is assumed that both pier walls will behave as a rigid body and they will rotate at the same time with the same rate and the lower plastic hinge will simultaneously appear in both of them at the same time; this hypothesis is based on the restriction that vaults give to the movement along certain directions. The other two plastic hinges are the following; one is located along the vault vertex where two pointed arches meet together between pier walls number 5 and 6 (is the same as that for the overturning of pier wall 5); the other one is located in the upper portion of the wall that is between pier walls number 7 and 8 which boundary occurs the end of the vault. The overturning of this macro-element was only analyzed in the only possible direction, Y direction (CM_A67_Y) and the results are shown in Section 3.4.4.

Figure 3.13. Selected macro-element for its overturning in Y direction (CM_A67_Y)

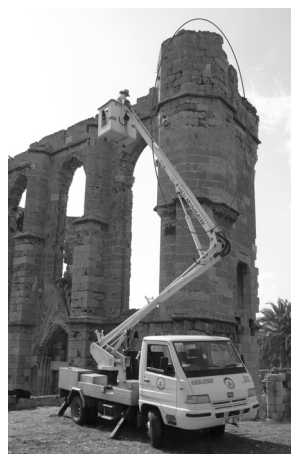
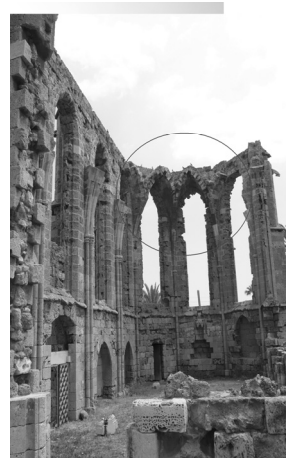
As it was demonstrated in Paragraph 4.3.2, the effect of the vaults in the model can be neglected in terms of stiffness, but in terms of mass it is important because it can make several contributions for the mode shapes that involve mainly the Apse. In this attempt, it was consider also important to include the mass of the tower located in the connection between the North and the West façades (Figure 4.9-a) and also the mass of the vaults located in the Apse (Figure 4.9-b).

Figure 4.9. Additional mass of the tower (a) and the vaults (b) included in the numerical model

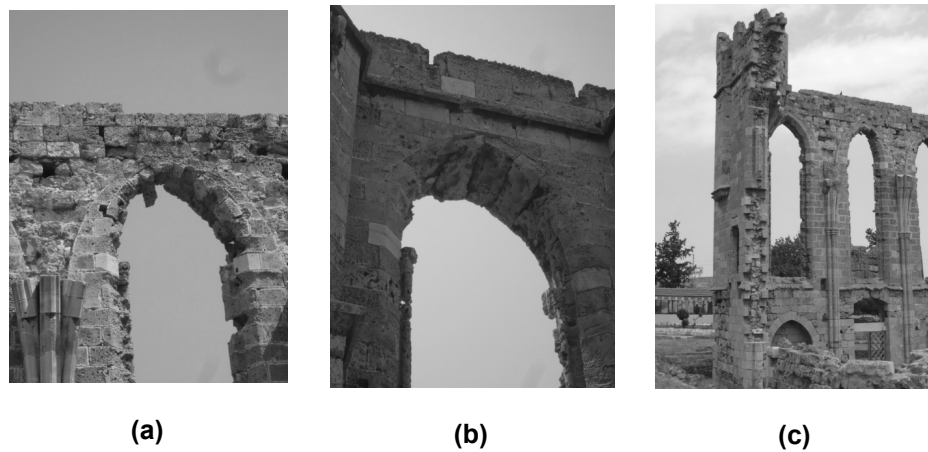
In this model the main attempt was to change the thickness of the top walls. Up to this model, the used thickness of the top walls is the one that it is stated in the geometrical information that was collected from the 1940s conservation works. But after a carefully review of the photos from the inspection and diagnosis works reported in (Lourenço & Ramos, 2008) it seems that the thickness of the top walls is the same as the bottom walls thickness. In Figure 4.18-a and Figure 4.18-b it can be seen that the thickness of the North façade's walls is constant in both, the interior side and the exterior sides. In the West façade the thickness is also the same through the entire wall from the base to the top as it is shown in Figure 4.18-c.

Figure 4.18. Interior (a) and exterior (b) views of the walls in the North façade, and cross section view (c) of the walls in the west façade

In order to model this new geometry feature, the thickness of the top part of the walls in the Apse and North façade was changed from 0.60m to 1.02m, and the thickness in the West façade was changed from 0.60m to 1.29m in order to model the constant thickness all over the wall; the physical and material properties used to define this model are shown in Table 4.7.

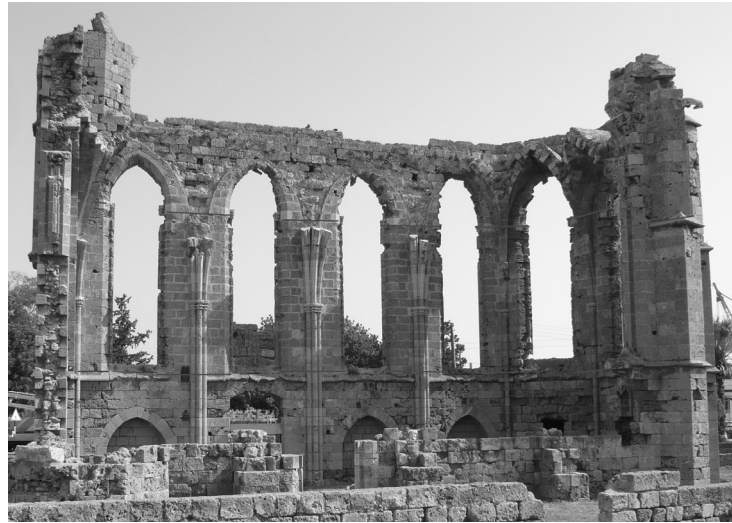
Figure 4.27. Three different zones in the walls of the church with a possible difference in the stiffness
